The Regional Network Office for Urban Safety (RNUS)

Monthly Report (February 2025)

Date: 7th March 2025

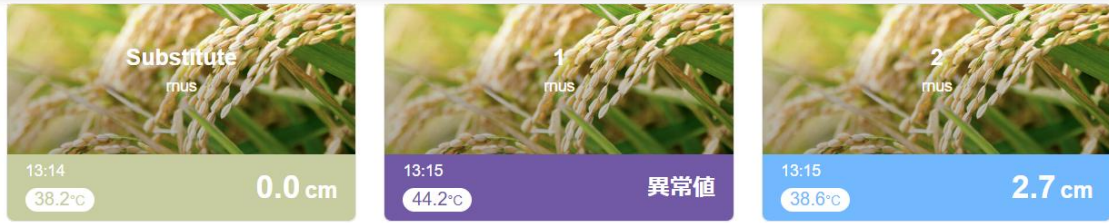
Figure-1. Farmo sensors dashboard configuration (left: Substitute device from manufacturer, middle and right: from RNUS) Middle one is not working properly now.

The paddy cropping season will begin in early March, during which water level sensors will be placed in both the AWD-applied and AWD-not-applied paddy fields within the RID compound. AWD-Alternate Wetting and Drying. Of the three water level monitoring devices (Manufacturer: Farmo/Japan) installed in the RID paddy field in Nakhon Pathom, one has been malfunctioning since late February. The RNUS team is currently coordinating with the manufacturer for troubleshooting. This device will undergo inspection during a site visit scheduled for March 11, 2025. Meanwhile, the other two devices are functioning properly, and real-time data on water levels and temperatures can be accessed via the dashboard, as illustrated in Fig-1 and Fig-2.

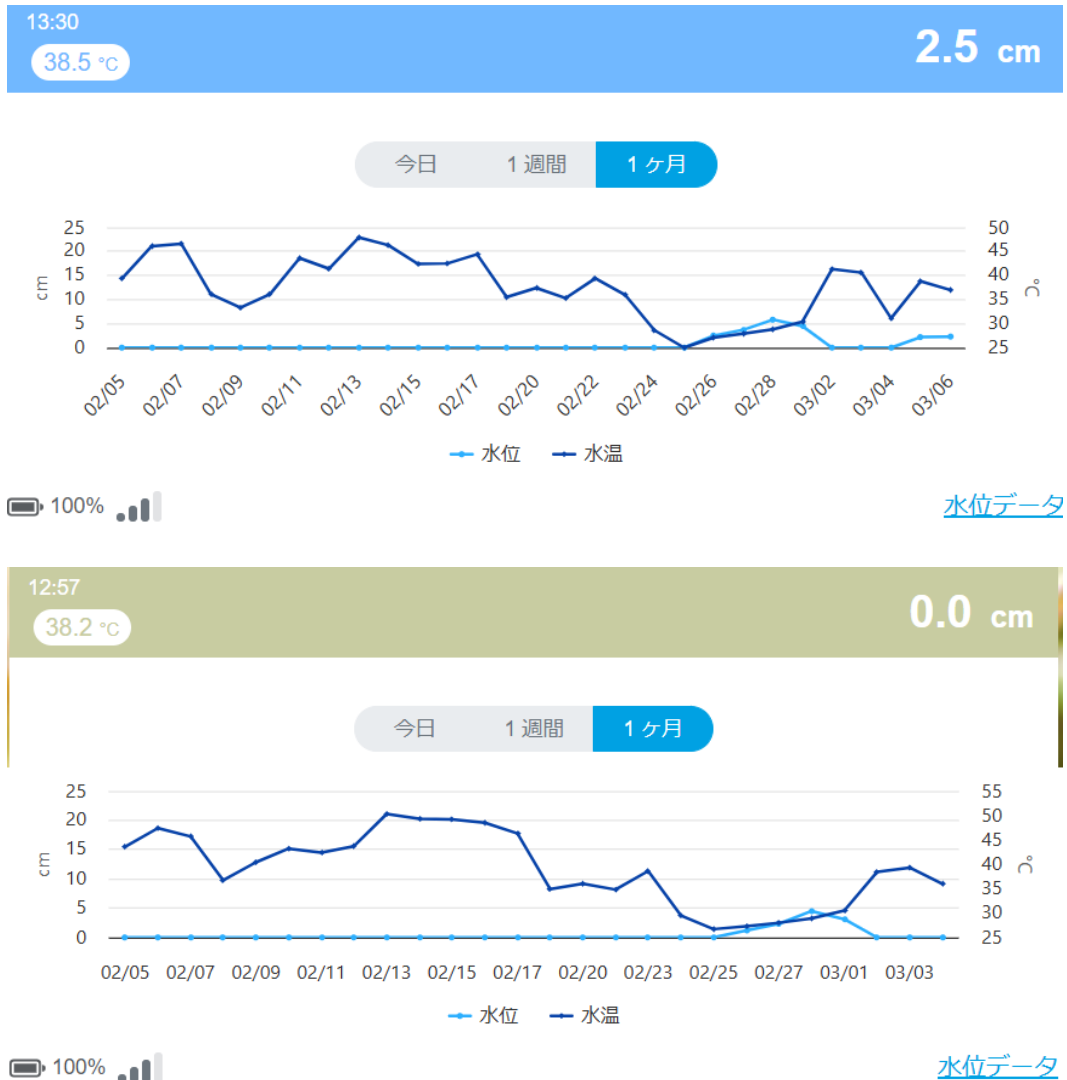
Figure-2. Real-time water level and temperature measurement from two functioning devices installed inside RID paddy field.

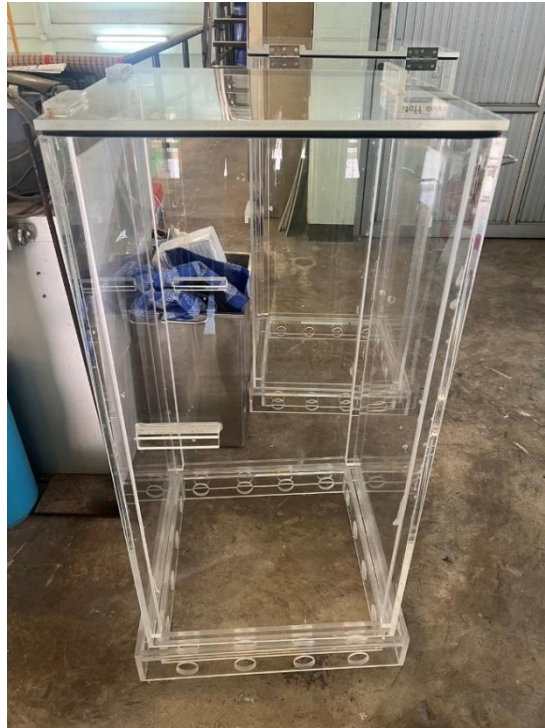
Figure-3. Closed chamber for methane emission measurement.

Methane emission measurement will be done on March 11, 2025, 2025. Prof. Takeuchi and Khun-Metta will visit to RID paddy field in Nakhon Pathom and will do the measurement. Two closed chambers, procured with RNUS budget from the Ambient Lab at AIT (Fig. 3), will be set up within the RID paddy field for this purpose.

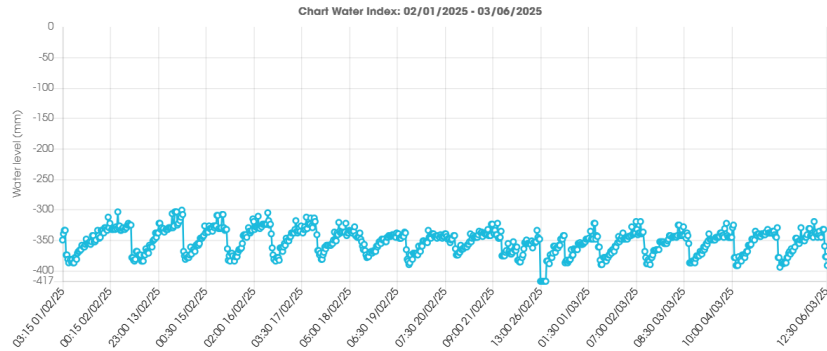
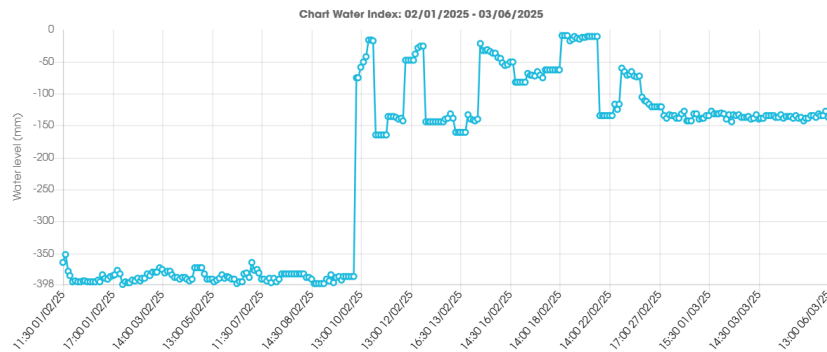
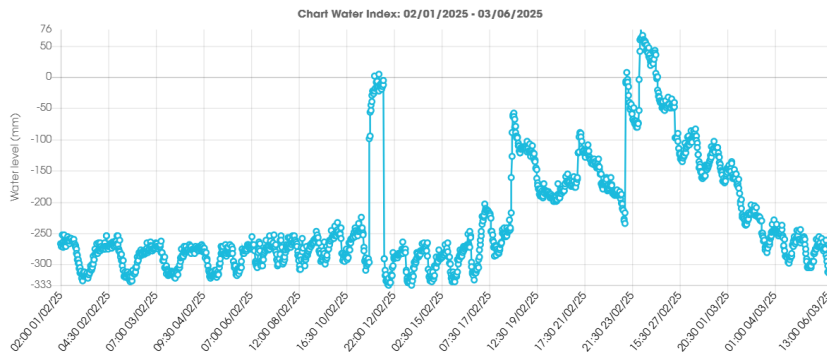
Figure-4. Real-time water level data from Rynan dashboard (sensors installed inside oil palm field in Prachuap Khirikhan, Thailand)

Water level sensors installed inside oil palm field is working well, and the real-time water level data can be accessed instantly through the dashboard, as illustrated in Figure 4. Anomalies in water level measurement needs to be validated with the irrigation activity and will be done accordingly.
